# Inspection Report

report number:	CTG2501230225E_SR120AR
product name:	Ultraviolet Water Sterilizer
trademark:	MASSPHOTON
model:	MP-UVC-3L
Applicant:	MASSPHOTON LIMITED
address:	Unit 542, 5/F, Building 5W, Phase One, Hong Kong Science Park, Pak Shek Kok, New Territories, Hong Kong
kind of inspection:	Entrusted test

product name	Ultraviolet Water Sterilizer		
model	MP-UVC-3L		
Additional model	MP-UVC-1L、MP-UVC-2L、MP-UVC-4L、MP-UVC-5L、MP-UVC-6L、MP-UVC-8L、MP-UVC-9L、MP-UVC-10L、MP-UVC-20L、MP-UVC-30L、MP-UVC-40L、MP-UVC-50L		
kind of inspection	Entrusted test		
Principal	MASSPHOTON LIMITED	Principal address	Unit 542, 5/F, Building 5W, Phase One, Hong Kong Science Park, Pak Shek Kok, New Territories, Hong Kong
manufacturer	XUZHOU LIYU ADVANCED TECHNOLOGY CO., LTD.	Manufacturer address	Floor 1, Electronic Information Workshop, No.5, Jingwei Road, Xuzhou High-tech Industrial Development Zone
sample size	2	Sample status	intact
Date of sample collection	2025.1.10	examination date	2025.1.10- 2025.1.13
testing environment	Temperature 20-25°C, humidity 50-60% RH		
inspection standard	GB / T 4208-2017 Housing protection class (IP code) testing specification		
inspecting item	See the inspection de

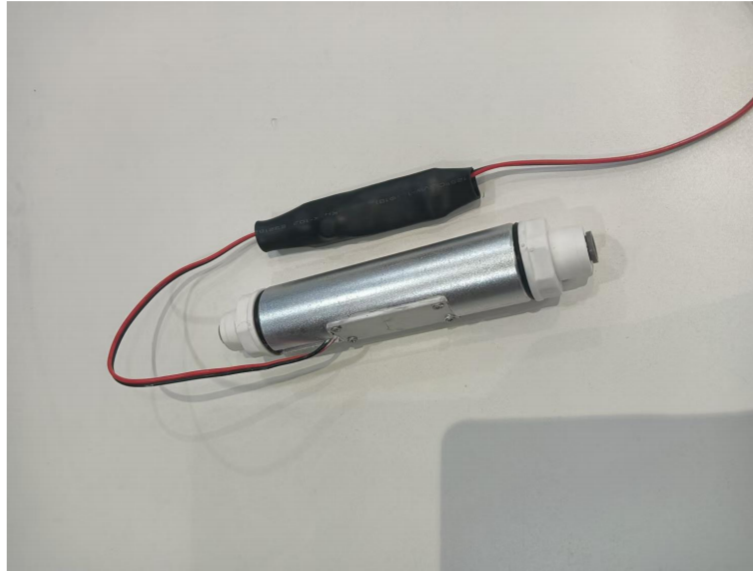
Photo

According to the standard:	GB / T 4208-2017 Housing protection class (IP code) testing specification*		
testing conditions:			
Detection conditions for IPX 8		detection result	judge
Waterproof test with 8 second digit (IPX 8) The samples were completely submerged in water and the bottom reached 1m depth from the water surface for 60 min After the test, the sample is tested to require no water accumulation inside the sample		meet the requirement	P
Detection conditions for the IP6X			
Dust test with first feature digit 6 (IP6X) Dust: talc powder The extraction rate is 40 times the shell volume per hour Test time: 8h After the test, the sample is tested, and there is no dust accumulation inside the sample		meet the requirement	P
Equipment use:	Soaking tank and dust proof box		
Detection environment:	Relative humidity: 25%~75%		
atmospheric pressure	86 kPa~106 kPa		
Final conclusion:	The ultraviolet water disinfectant model MP-UVC-3L has passed the protection level (IP68) test.
